Manhole Inspection Summary

Manhole # S43E__021MH

Insp Date: **6/10/08 10:20 AM**

Location Address: **32 s broadway**

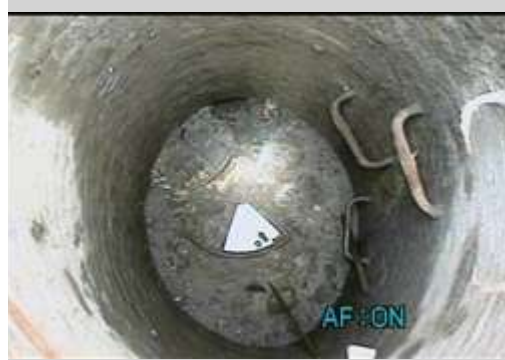
Top View

top view & steps

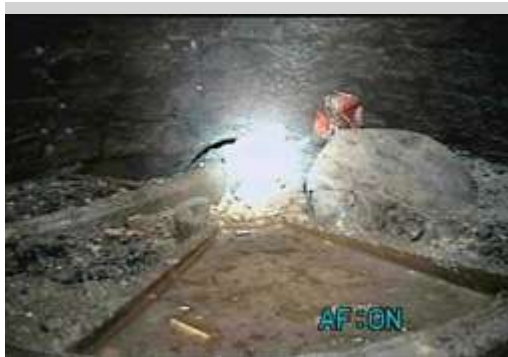
Defect 2

Condition: ☐ Sound ☐ Cracked ☐ Root Intrusion ☐ Deteriorated ☐ Leaks ☒ **Debris**

channel debris

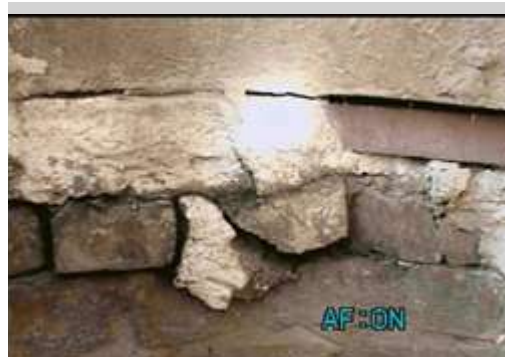
Defect 1

Condition: ☐ Sound ☒ **Cracked** ☐ Root Intrusion ☒ **Loose Brick** ☐ Deteriorated

chimney loose bricks, cracked, frame adj

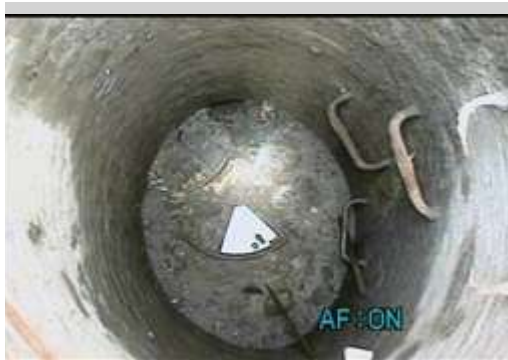
Defect 3

Count: **5** Missing: **2** ☒ **Corroded**

corroded steps

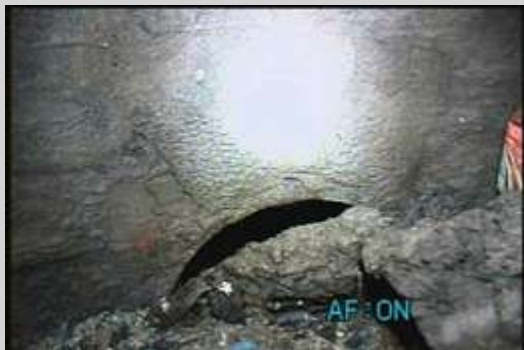
12 O'Clock Outflow

Deposits: ☐ None ☐ Mud ☐ Sludge ☒ **Debris** ☐ Grease

Silt Depth: **5** (in.) Deposits Extent: **Heavy**
